Slys Quarry, Tullmorgan- Jackbulbin Road, Mororo

Annual Review

Newman Quarrying Pty Ltd

23 November 2021

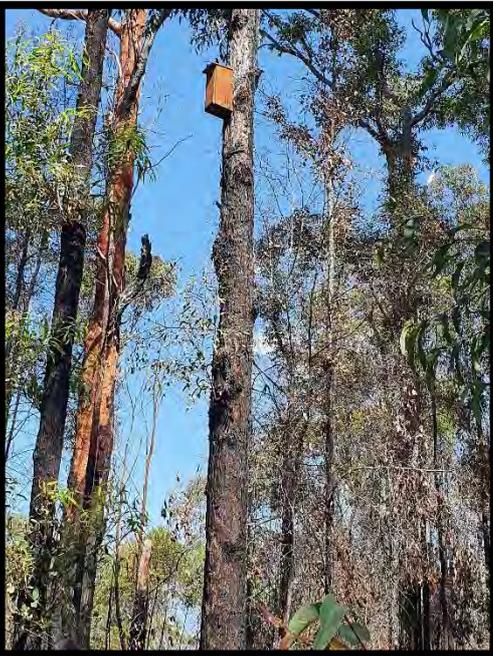
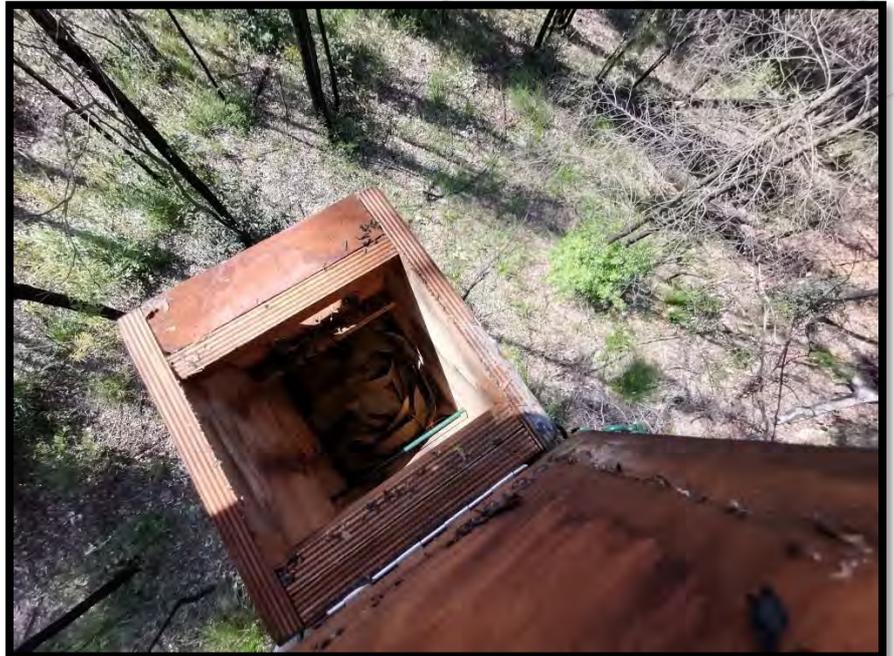
None of the four nest boxes showed recent signs of evidence. The Sugar Glider (*Petaurus breviceps*) leaf nest in Nest Box 4 was still evident but showed no recent sign of use (Plate 1-1). Similarly, there was no recent sign of use in Nest Box 11 which had been previously used by a Common Brushtail Possum (*Trichosurus vulpecula*).

Plate 1-1. Nest box 4 and the disused glider nest.

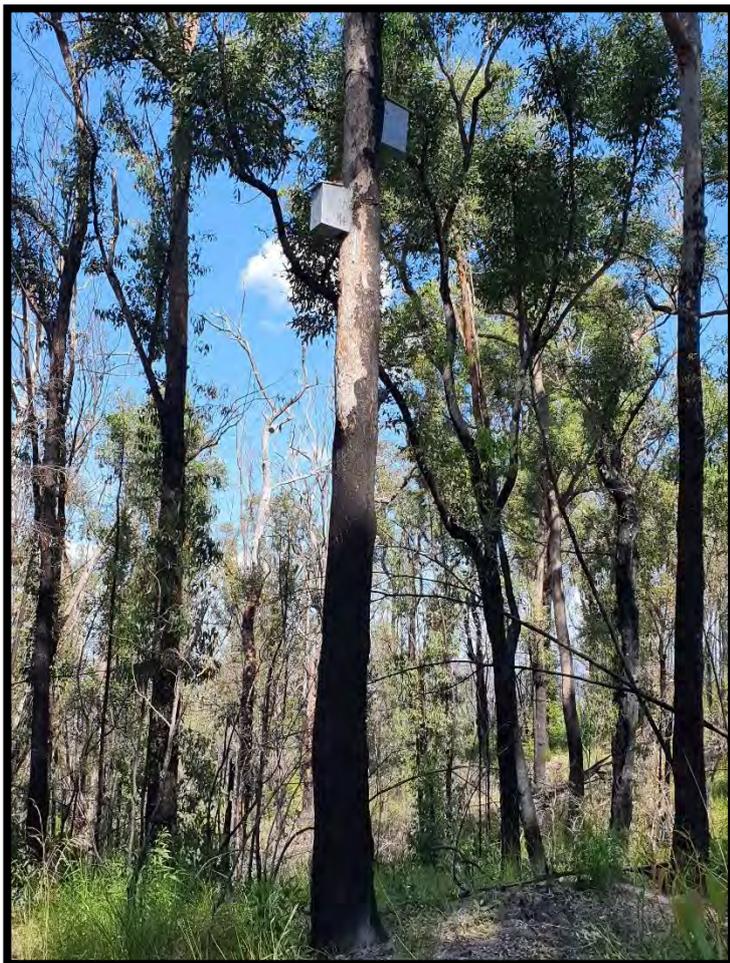
From a maintenance perspective, no feral species (i.e. European Honey Bee or Common Myna) were recorded. Eight cyplas nest boxes from Hollow Log Homes were installed during the survey and this included positioning boxes on some new trees of the same species as well as some on those trees which previously contained boxes (Plate 1-2).

Plate 1-2. Newly installed CYPLAS nest boxes 9 and 10 replacing those destroyed by fire.

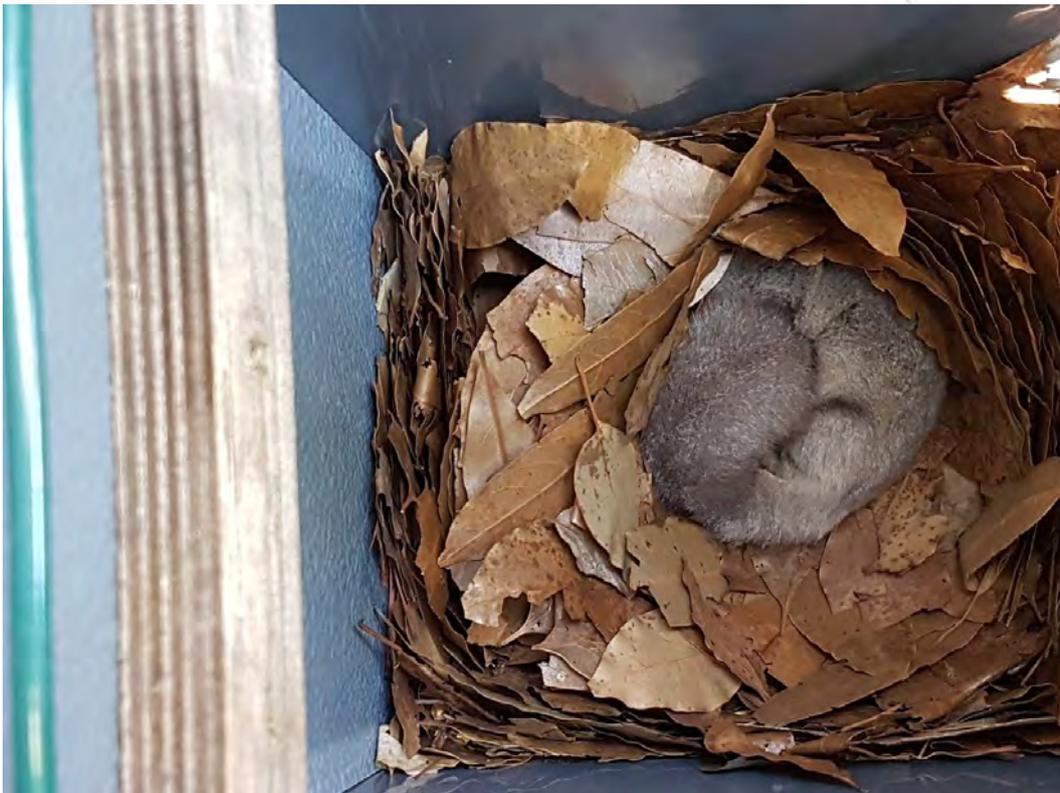
Three of the twelve nest boxes showed recent signs of use by native wildlife. Nest Box 1 was occupied by two Gould's Long-eared Bats (*Nyctophilus gouldi*) whilst a Sugar Glider (*Petaurus breviceps*) was found in Nest box 10 (Plate 1-1). Some leaves consistent with Brushtail Possum was observed in Nest box 2 and is likely to be a Common Brushtail Possum (*Trichosurus vulpecula*). Two of the inhabited nest boxes were replacement boxes installed after the 2019 wildfire. The Gould's Long-eared Bats were found in a specific two chambered bat box which has been previously used by micro bats in the past.

Plate 1-1. Nest box 10 with Sugar Glider.

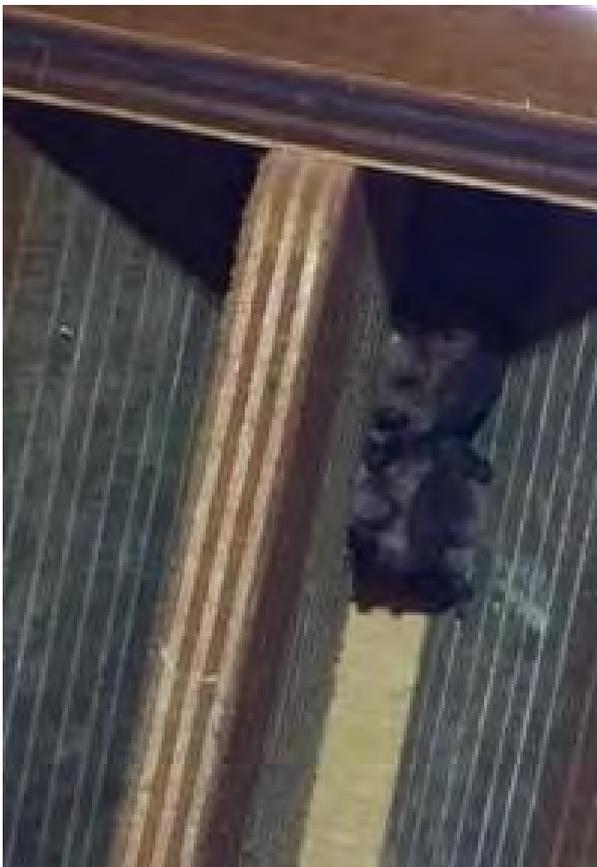
Plate 1-2. Nest box 1 with two Gould's Long-eared Bats.
